# PrintServer 17/600 Printer

## Maintenance Advisory

EK-PRT17-MA. A01

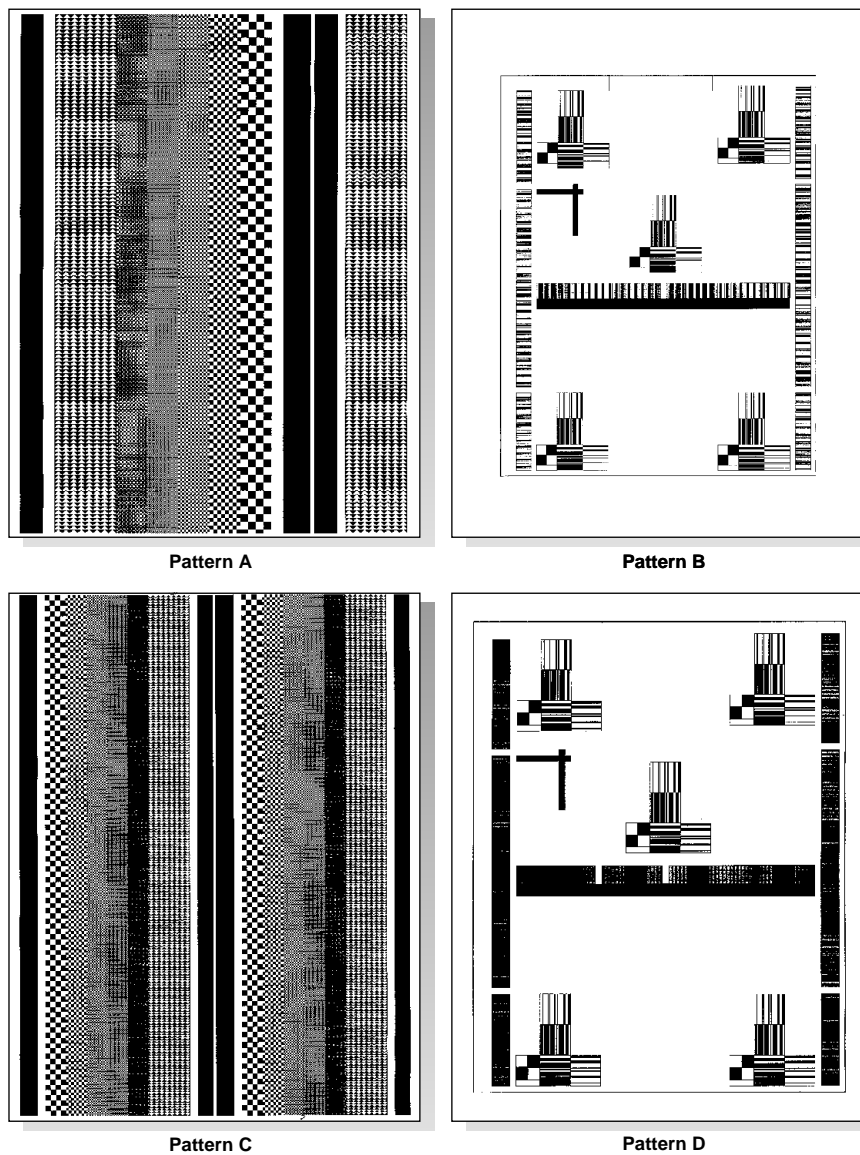
Figure 2–1 New V2.1 Controller Board Test Patterns

Figure 2–1 shows the 400 and 600 dpi test patterns that are printed by a PrintServer 17/600 printer. An example of the PrintServer 17 300 dpi pattern appears in Figure 4-2 of the service guide.

- Patterns A and B are printed at 400 dpi. Compare the B and D test test patterns. Notice how the B pattern is smaller on the page than pattern D. This only happens at 400 dpi.
- Patterns C and D are printed at 600 dpi. Compare the C and the A test patterns. Notice how the C test pattern is horizontally compressed. This compression effect increases as the density (dots-per-inch) increases.
