RM 02 / 03

Problems and Hints

SUBJ: RM03 HEAD ALIGNMENT

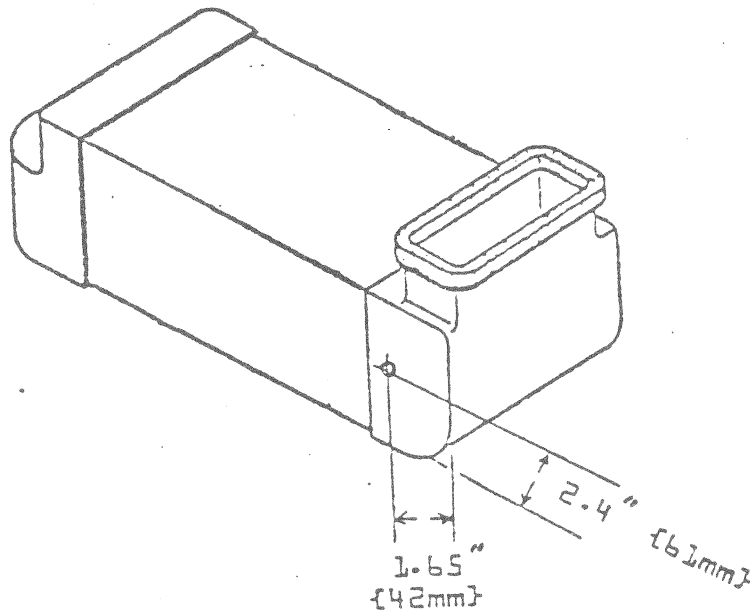
SUBJECT: SMD ABSOLUTE FILTER REPLACEMENT DETERMINED BY FILTER-FLOW PRESSURE MEASUREMENT.

IF ABSOLUTE FILTER DOES NOT HAVE A HOLE AND PLASTIC PLUG INSERTED AT LOCATION SHOWN IN FIGURE BELOW, REMOVE FILTER FROM DRIVE AND DRILL .25 INCH {6.35mm} HOLE. THOROUGHLY CLEAN SHAVINGS FROM FILTER BEFORE INSTALLING BACK INTO DRIVE. PLASTIC PLUG MUST BE INSERTED AT ALL TIMES EXCEPT WHEN TAKING PRESSURE MEASUREMENT.

PROCEDURE: REMOVE POWER FROM DRIVE. INSURE PRIMARY FILTER IS CLEAN AND ALLOWING MAXIMUM AIR FLOW. GAIN ACCESS TO ABSOLUTE FILTER, REMOVE PLASTIC PLUG AND INSERT TUBING ATTACHED TO PRESSURE GAUGE. APPLY POWER TO DRIVE AND LOAD HEADS. IF PRESSURE IS .5 INCH-WATER OR LESS, FILTER SHOULD BE REPLACED. ; IF PRESSURE IS ABOVE .5 INCH-WATER, FILTER NEED NOT BE REPLACED AT THIS TIME. REMOVE TUBING, INSERT PLUG, AND RETURN UNIT TO NORMAL OPERATION.

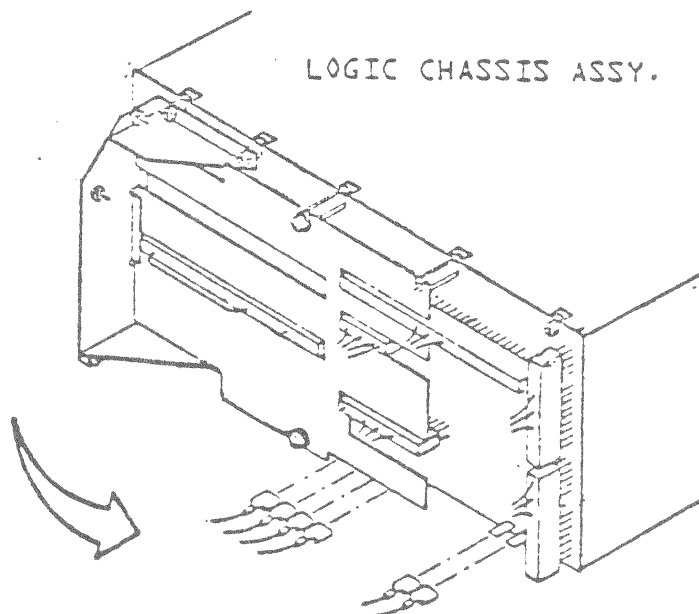
SPORADIC ± 5 VOLTAGE DRIFT ~~FOR~~ INFORMATION ONLY

BACKGROUND: FIELD REPORTS OF SPORADIC VOLTAGE FAULTS HAVE BEEN TRACED TO POSSIBLE DETERIORATING CONTACTS OF THE ± 5 VOLT RECEPTACLES AT THE LOGIC CHASSIS. (SEE FIGURE BELOW) SINCE THE FACTORY HAS BEEN UNABLE TO DUPLICATE THE REPORTED PROBLEM, IT IS SUSPECTED THAT AN UNKNOWN COMBINATION OF TEMPERATURE, HUMIDITY AND AIR FLOW, MAY BE HAVING AN ADVERSE AFFECT ON THESE CONTACTS.

SOLUTION: SOLDERING THESE CONNECTIONS HAS BROUGHT POSITIVE RESULTS AT THOSE FIELD SITES ORIGINALLY REPORTING THE PROBLEM.

IF ANY VOLTAGE DRIFT PROBLEMS ARE BEING EXPERIENCED, IT MAY BE ADVANTAGEOUS TO SOLDER THESE SLIDE-ON RECEPTACLES TO THE CONNECTING TABS, ESPECIALLY THE ± 5 AND ± 20 VOLT CONNECTIONS.
