MARCH 1982

TECHNICAL DOCUMENTATION CHANGE NOTICE

This Change Notice provides information affecting the KC750 Technical Manual - EK-KC750-TM-002.

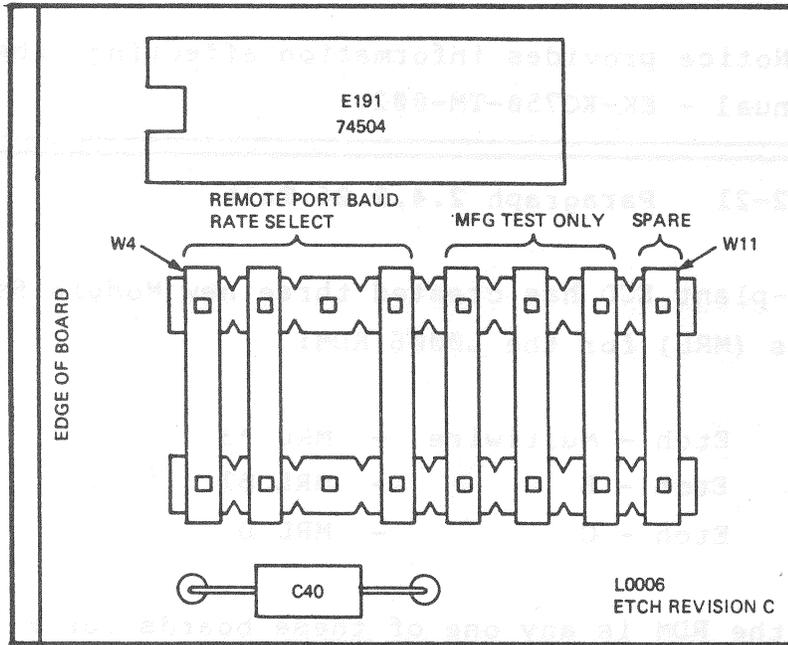
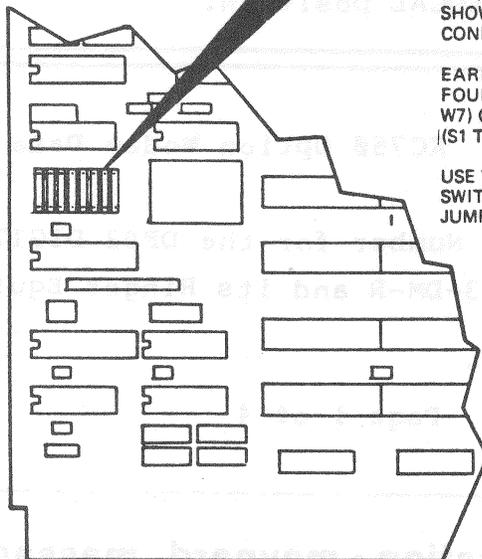
o Page 3-5 Figure 3-2 Location of Baud Rate Jumpers on the RDM

A note is added to the figure to indicate that only Revision C etch boards have the set of eight jumpers. Earlier boards have either a set of four jumpers or a four-switch pack.

ETCH REVISION C BOARDS HAVE THE EIGHT-JUMPER PACK (W4 THROUGH W11) AS ILLUSTRATED. THIS FIGURE SHOWS THE FACTORY-SET 300 BAUD CONFIGURATION.

EARLIER BOARDS HAVE EITHER A FOUR-JUMPER PACK (W4 THROUGH W7) OR A FOUR-SWITCH PACK (S1 THROUGH S4).

USE TABLE 3-2 TO CONFIGURE SWITCHES, TABLE 3-3 TO CONFIGURE JUMPERS.

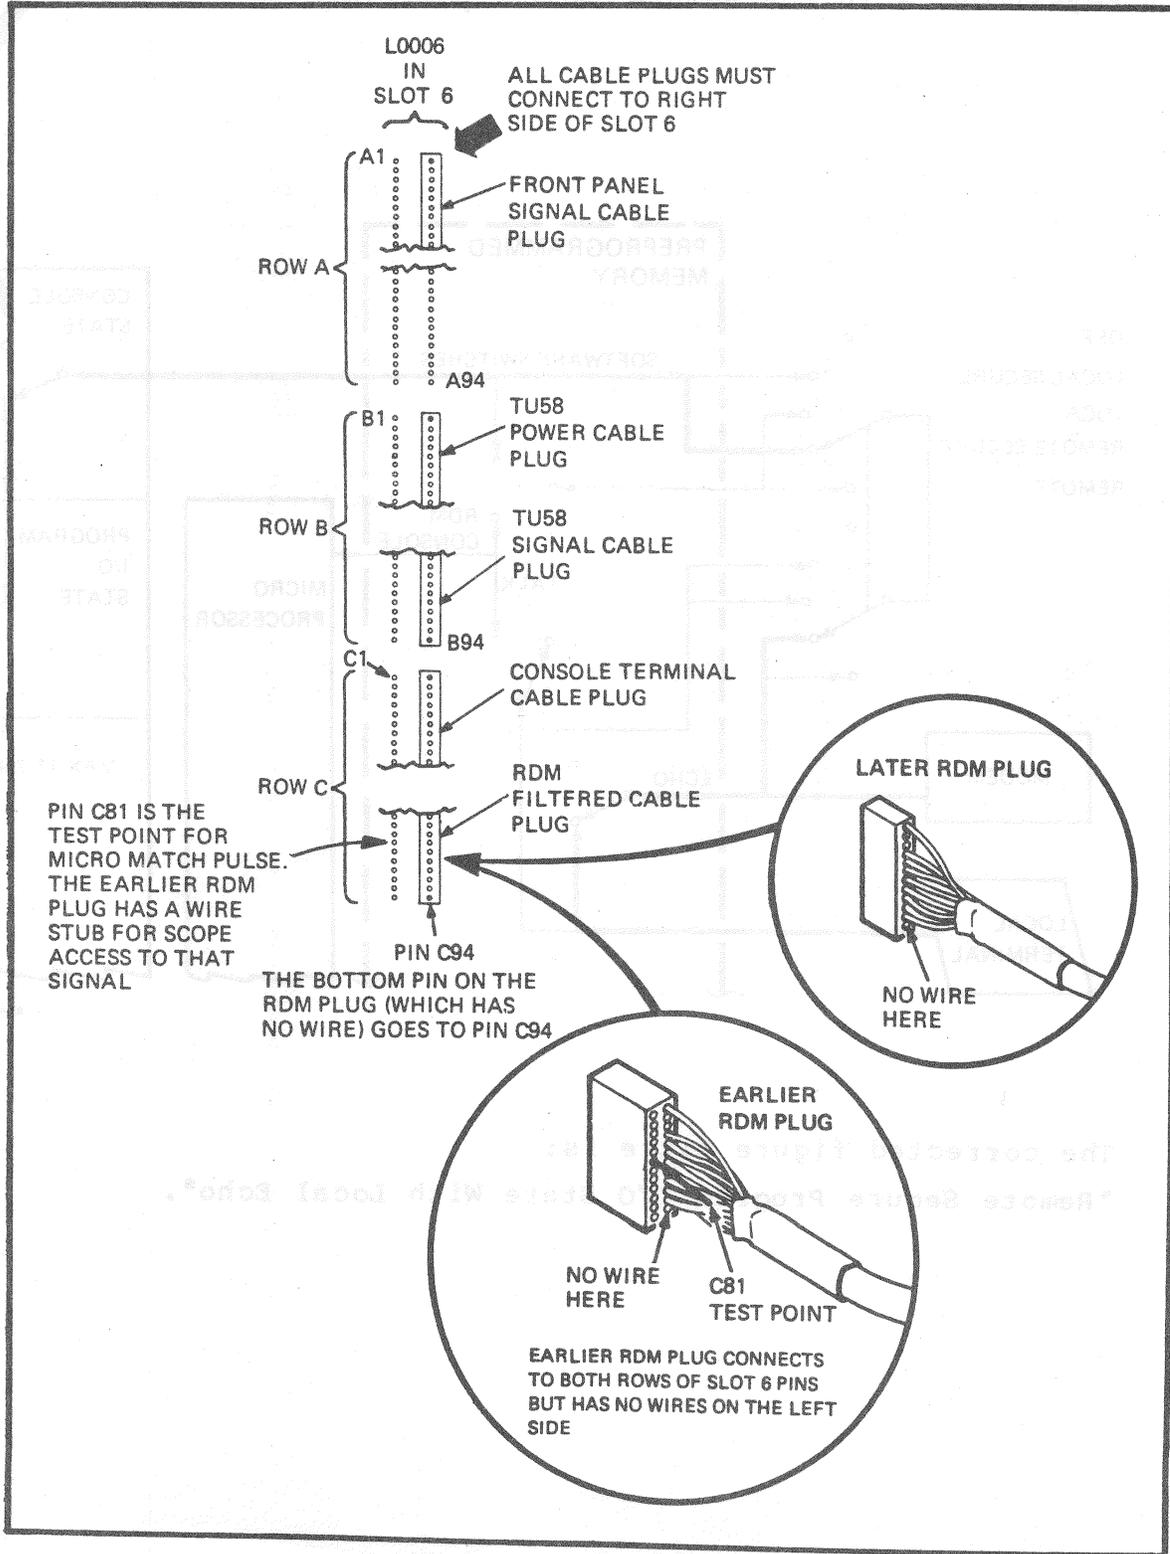
The figure is changed to show that the TU58 Power Cable plug must be connected to the pins on the right side of slot 6. Other changes show the two types of RDM plugs and how they are connected.

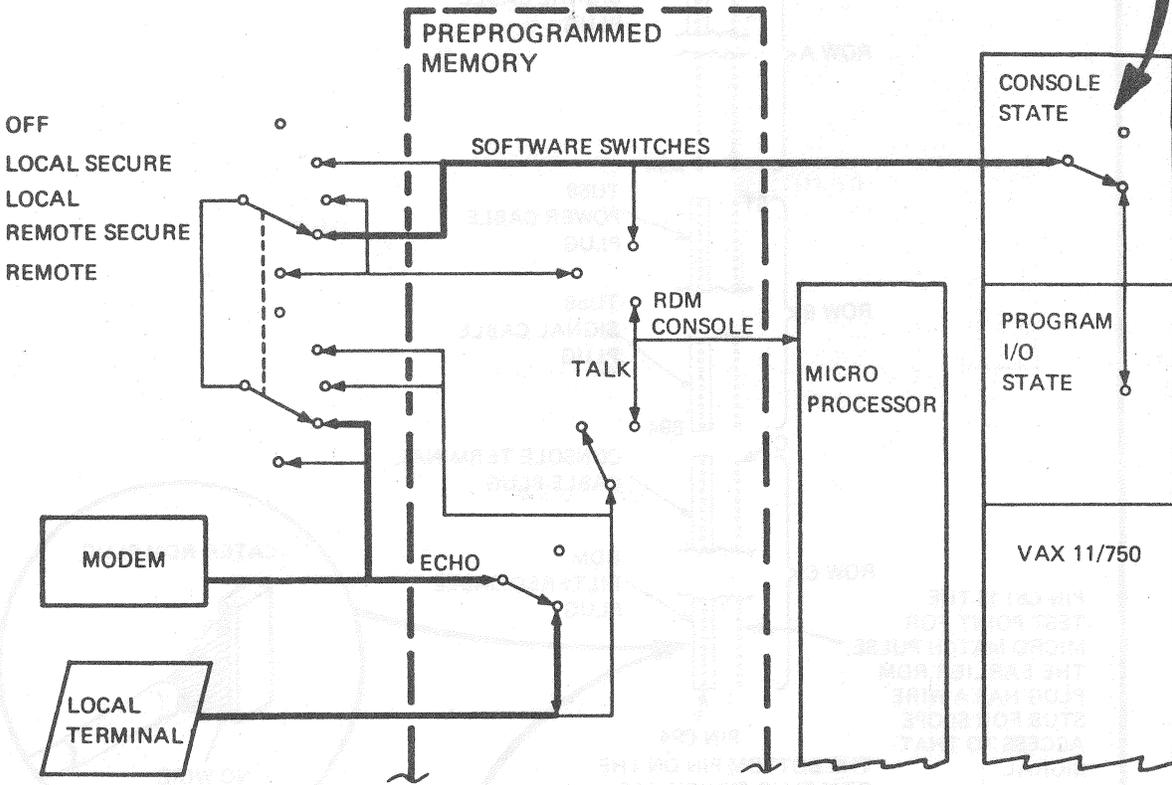
Figure 4-3 Remote Secure VAX Console State With Local Echo

The figure is changed to show Program I/O State instead of Console State. Console State cannot be entered when the keyswitch is in the Remote Secure position.

The corrected figure title is:
"Remote Secure Program I/O State With Local Echo".
