RM 02 / 03

Problems and Hints

SUBJ: RM03 HEAD ALIGNMENT

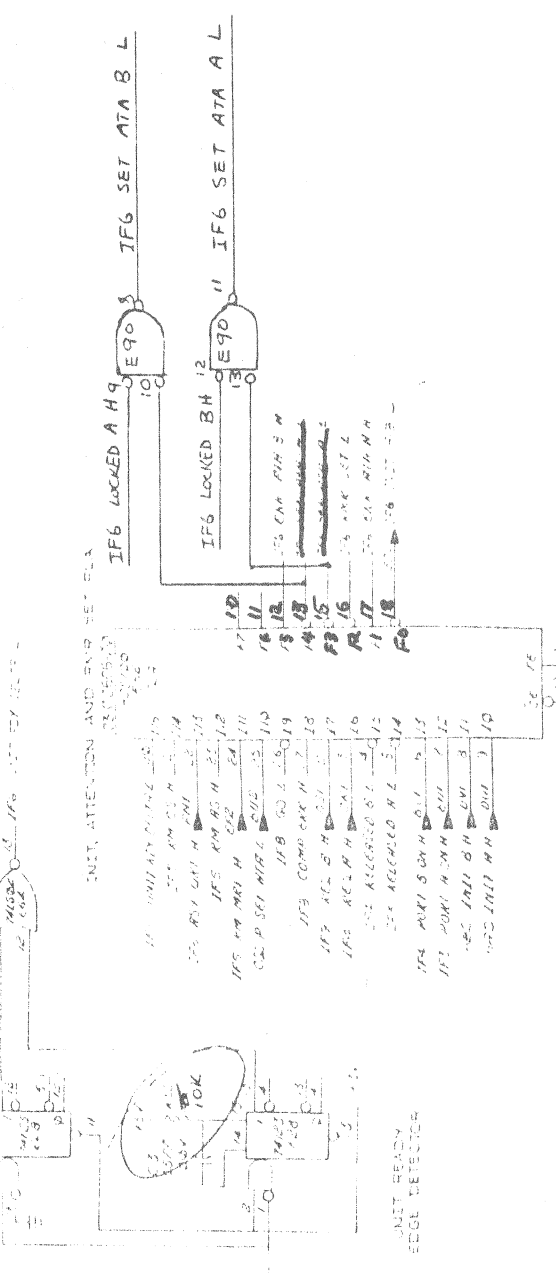
DUAL PORT MULTIPLEXER FOR HAND-MADE
SIGNALS, ATTENTION AND VOLUME SELECT.
