hp AlphaServer ES47, ES80, and GS1280 V7.3 Firmware Release Notes and Update Procedures

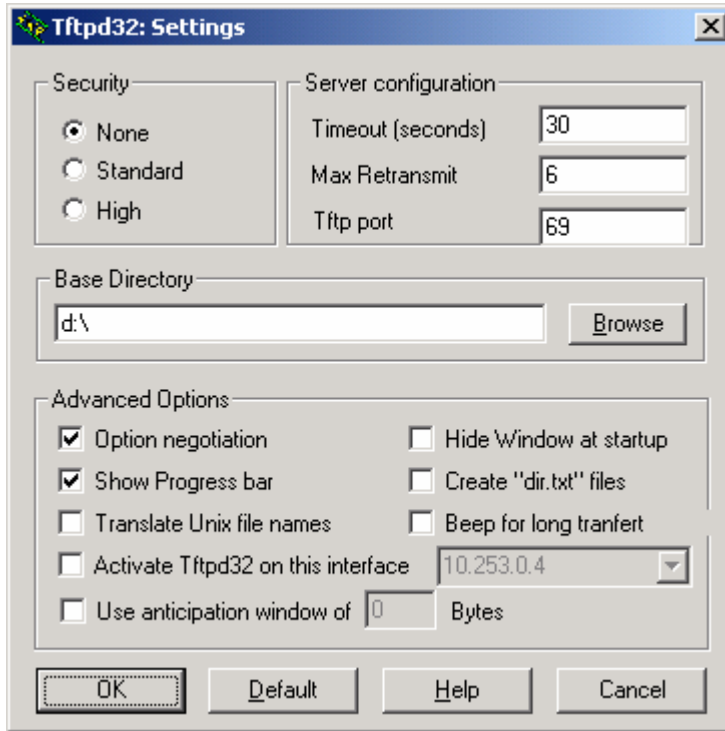
Start the TFTP Server on the PC by invoking `tftpd32.exe`. A copy is found on the AlphaServer ES47/ES80/GS1280 Firmware CD, to be copied to a convenient directory on your local PC. Then change the settings to point the directory containing the files to be upgraded.

Click OK.
