4. Inspect the take-up leader inside the TK50.

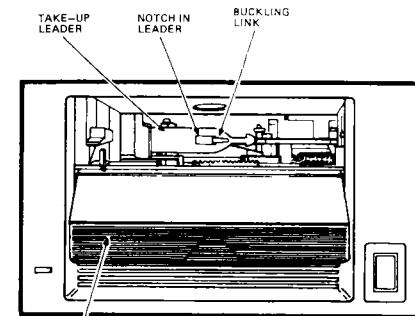
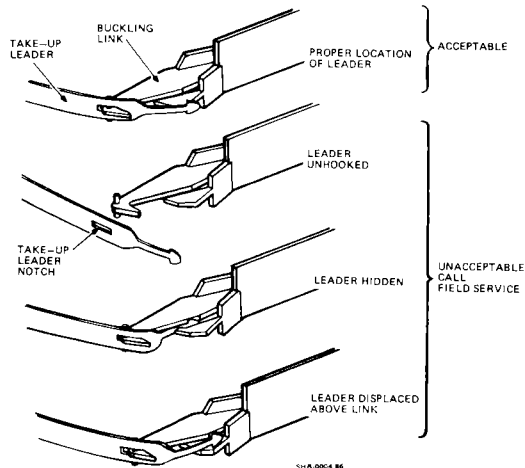
Make sure that the take-up leader inside the tape drive is in the correct position, as shown below. Since the take-up leader in the TK50 must mate with the leader inside the tape cartridge, it is important that both are in their correct positions.

CAUTION: Do not try to fix the take-up leader inside the tape drive. If it is not in the correct position, call Digital Field Service.
